Freshwater ecosystems of Tiritiri Matangi

March 2015

Graham Surrey,
Surrey Environmental Ltd

Executive Summary

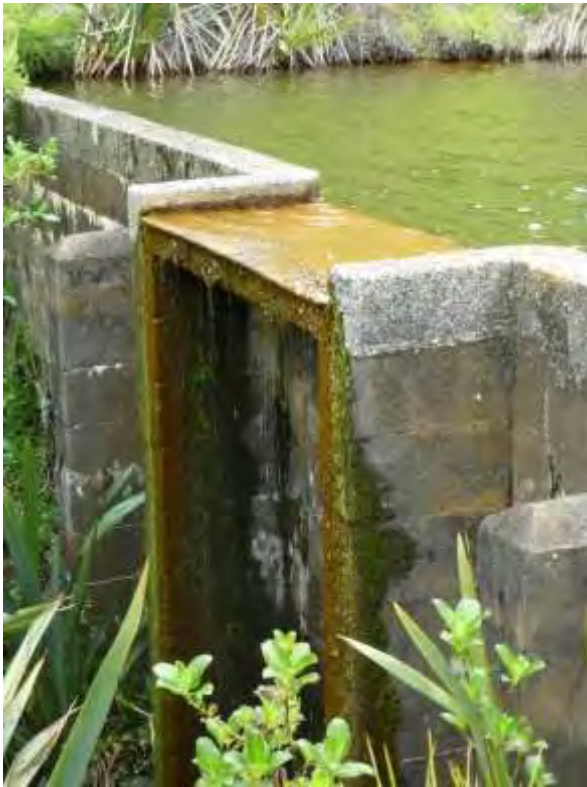
Figure 9: Spillway structure on Upper Emergency Landing Dam, showing 'perched' overhang

Access for fish into the Upper Emergency Dam is currently hampered by the presence of the overhanging or 'perched' spillway structure (see Section 3.2 and Figure 9 & Figure 10). The design of the structure makes it impossible for fish to climb the dam face when the flow is confined to the spillway (i.e. in low flow conditions), so it is recommended that modifications are made to improve fish passage over the dam. The steel plate forming the base of the spillway should be removed and the spillway entrance blocked off so that it is the same height as the rest of the dam wall.

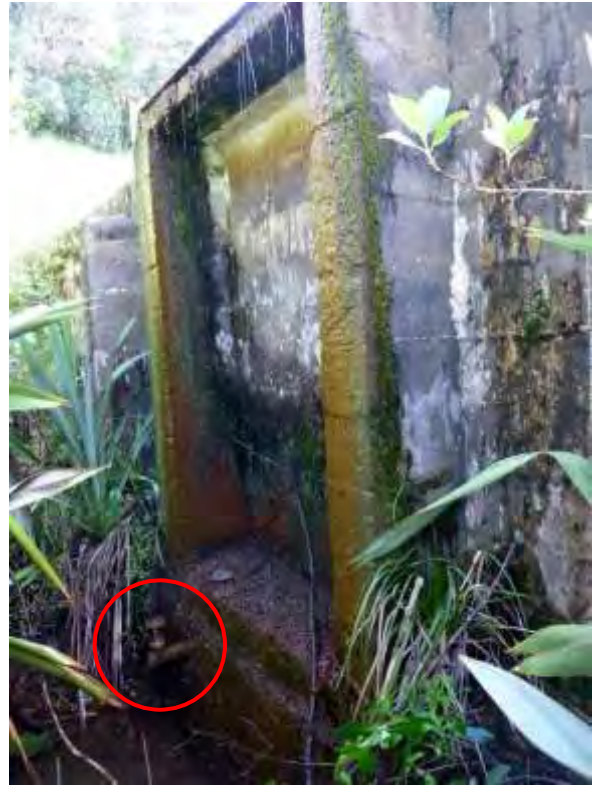
Figure 10: Base of spillway structure, showing drainage valve (circled)

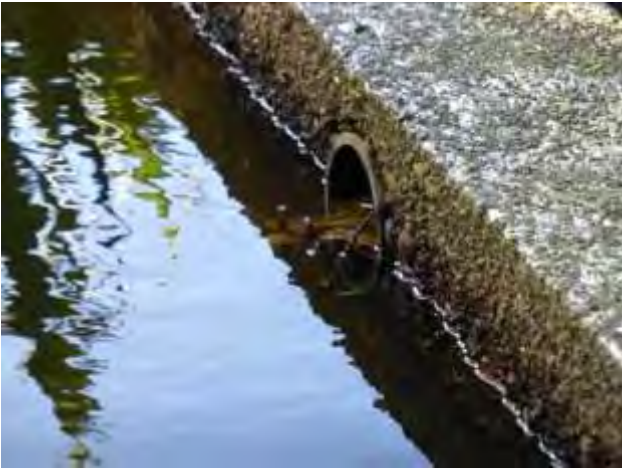
The outflow for the dam consists of a horizontal metal pipe set in the dam wall and connected via a 90° join to a vertical pipe on the downstream side of the wall (Figure 15Figure 16). At the time of the survey the water level of the dam was at the level of the outflow pipe, but very little discharge was observed.

Figure 15: Outlet pipe from Lower Emergency Dam

The Lower Emergency Dam has an outflow consisting of a metal pipe with a 90° angle in it, as previously described in Section 3.3 and illustrated in Figure 15 & Figure 16. This pipe is currently impossible for fish to use for climbing upstream into the dam and has reportedly been previously blocked by a dead eel that was trapped while trying to exit the dam downstream, so it is recommended that it be permanently blocked off at the upstream end where it exits the dam wall.

As well as blocking the outlet pipe, a two-metre wide section of the dam wall in the middle of the span next to the pipe should be lowered by approximately 10 cm to provide a preferential spillway for flow from the dam to trickle down the dam face. Allowing the flow to exit vertically down an area of the dam face will make it possible for climbing fish species to easily scale the concrete surface and enter the dam. As long as the area remains damp then mosses will thrive on the dam face (see Figure 60), providing moisture retention and extra purchase for eels and banded kokopu to climb their way upwards into the dam.

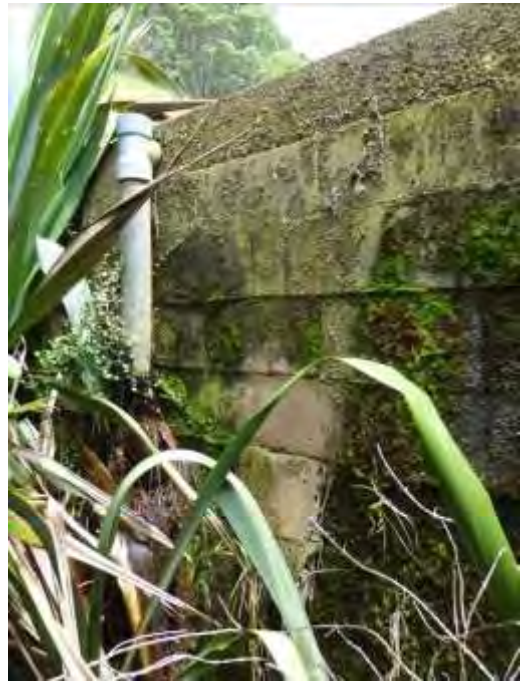
Figure 16: Vertical section of outlet pipe on dam wall

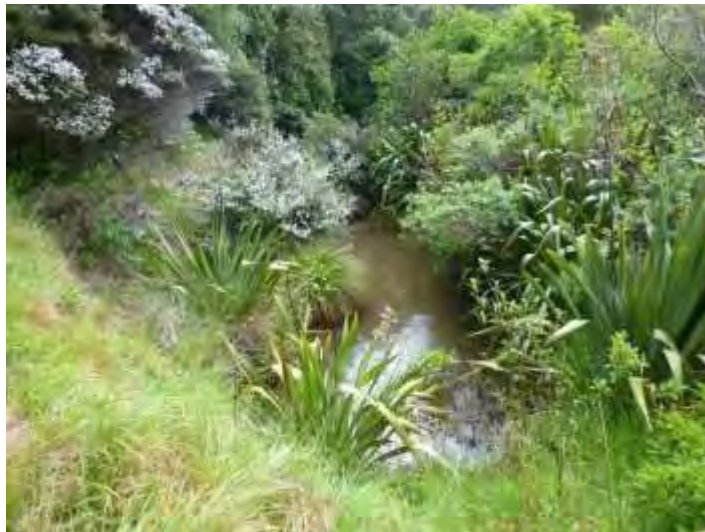
Water depth was very shallow (<1 m deep) and there was no flow into or out of the pond observed. As implied by the name of the pond, the lack of water movement, small size and shallow depth resulted in low levels of dissolved oxygen within the water column.

Figure 21: Stagnant Pond and surrounding vegetation

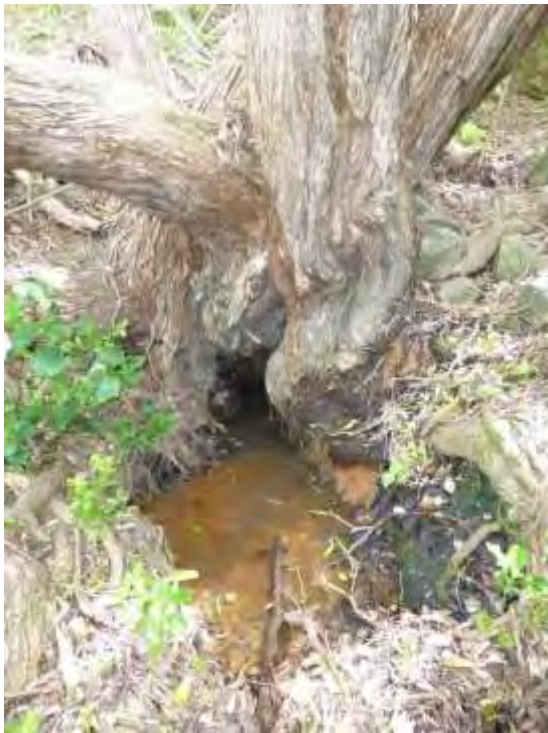
The Bush 3 Stream is located to the north of where Hobbs Track meets Hobbs Beach. The lower reaches of this stream contained a number of stagnant pools with heavy bacterial growth, indicating a lack of flow and warm water temperatures (Figure 44).

Figure 44: Stagnant pool with bacterial growth at the bottom of the Bush 3 Stream

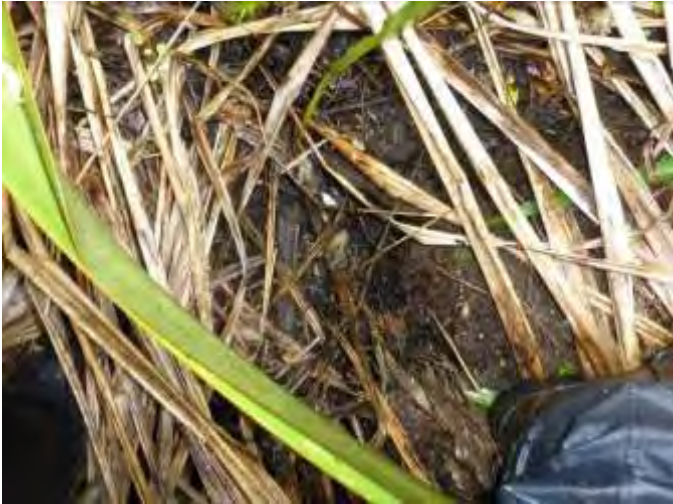
Immediately after exiting the Lower Silvester Dam the stream disappears into thick flax, which covers the valley below. Halfway down the valley there was no defined stream channel, with only a damp flow path present (Figure 47).

Figure 47: Damp flow path through flax

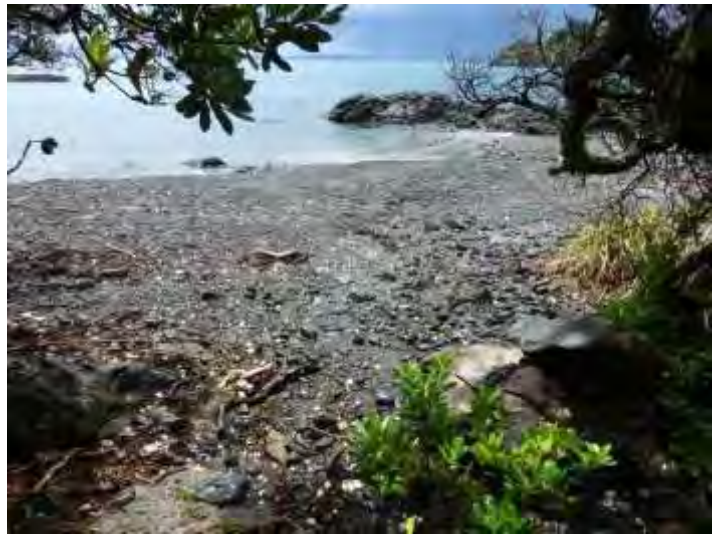
Figure 50: View of the stream disappearing into the shingle beach at Northeast Bay

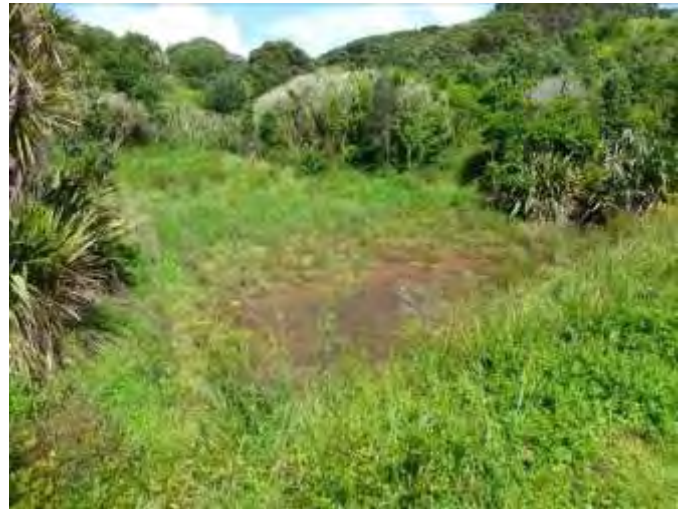
The Fisherman's Bay Pond was constructed in the mid-90s but was prone to leaking due to root intrusion. It was rebuilt in 2013 but continues to leak and is due to be repaired in March 2015 by lining it with bentonite (Ray Walter, pers.comm.).

At the time of the survey the pond was completely dry and overgrown with plants (Figure 58).

Figure 58: View of the dry and overgrown Fisherman's Bay Pond

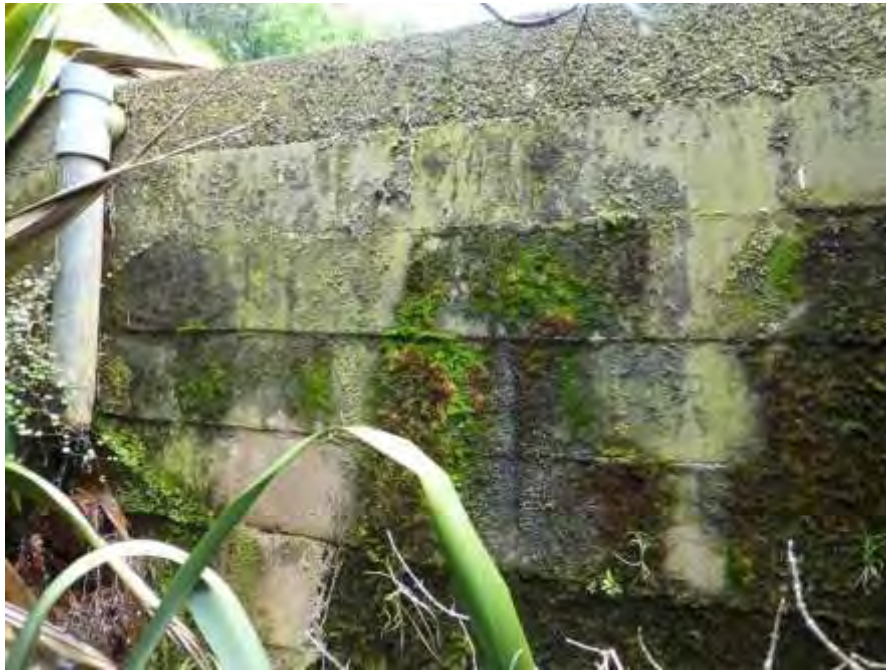
Figure 60: Mosses growing on the face of the Lower Emergency Dam
