Freshwater ecosystems of Tiritiri Matangi

March 2015

Graham Surrey,
Surrey Environmental Ltd

Executive Summary

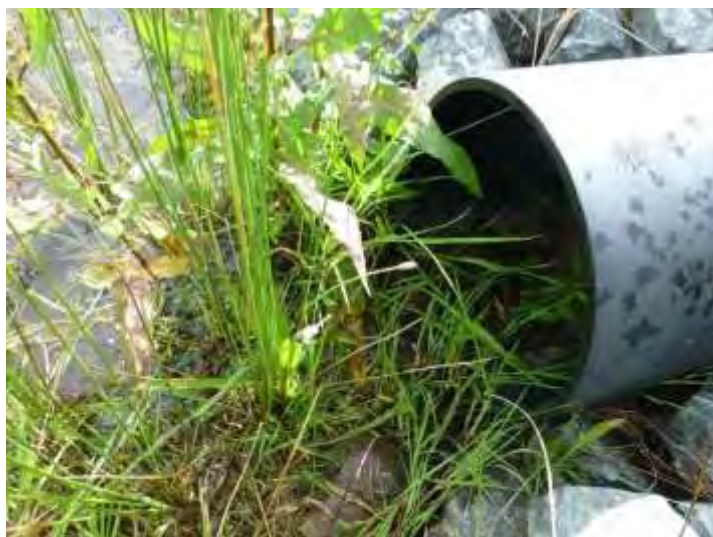
Figure 25: Outflow pipe for Upper Silvester Dam

The outflow from the dam is via a 300mm PVC pipe, which is embedded in rip-rap (Figure 25). At the time of the survey there was no flow occurring out of the dam.

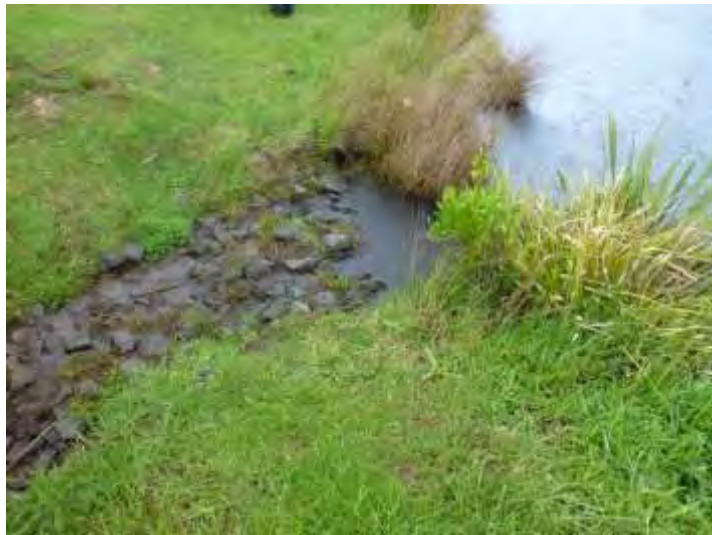
Figure 29: Outflow from Lower Silvester Dam

The Lower Dam is the larger of the two dams within the Silvester Wetlands and was constructed at the same time as the Upper Dam (around 15 years ago). The dam face currently has a crack running through it and it is due to be repaired (Ray Walter, pers.comm.).

The outflow from the dam is via a shallow channel reinforced with small rocks (Figure 29). At the time of the survey the water level of the dam was level with the outflow, which was damp but barely flowing.

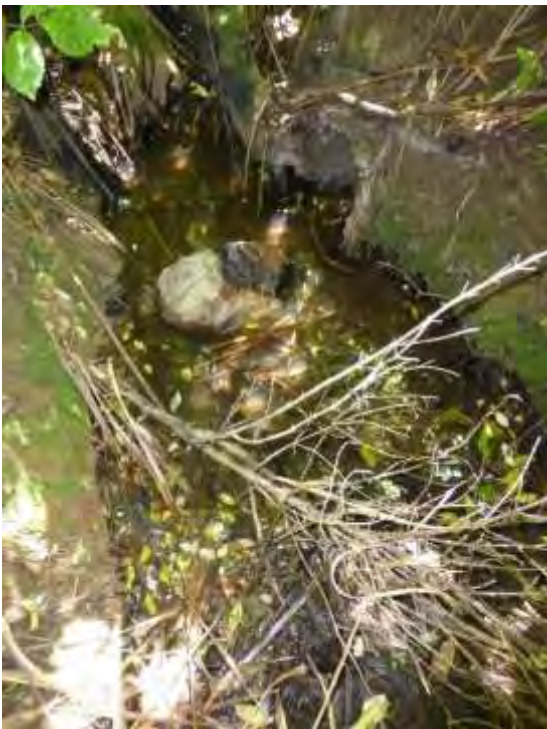
Figure 38: Typical small pool in mid-catchment area of Kawerau Stream

The length of the Kawerau Stream catchment was surveyed from the bridge above the Kokopu Pool to the point where the stream meets the beach. The majority of the stream was composed of a series of small pools with undercut banks, separated by stretches of stream channel that were completely dry (see Figure 38). It appears that the stream is intermittent in nature, only flowing fully when a large amount of rainfall has occurred within the catchment.

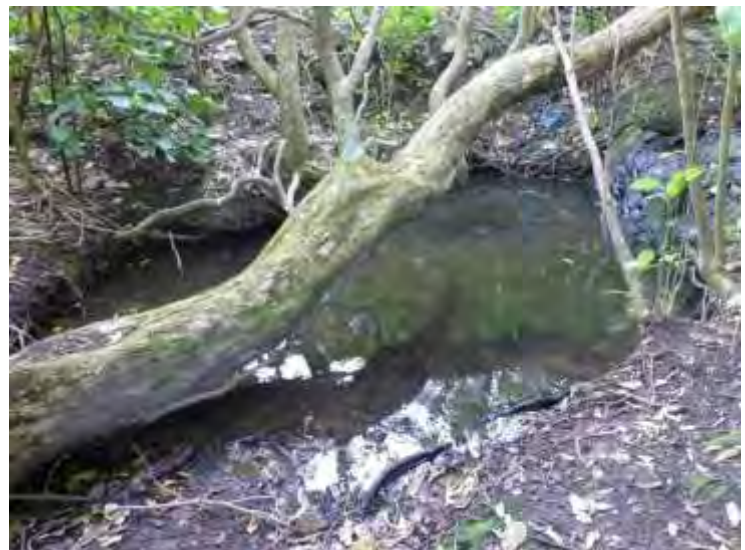
Figure 39: Large pool at downstream extent of Kawerau Stream

At the lower end of the catchment, approximately 100m from the beach, there were a series of three big pools located under sizeable pohutukawa trees, the largest of which measured 6m long by 2.5m wide and 0.3m deep (Figure 39). All pools featured undercut banks and a high degree of shade from riparian vegetation, making them some of the best stream habitat available for fish on the island.

Further downstream, a build-up of leaf litter and debris at the base of flax bushes bordering the beach prevented the stream from reaching the sea. There was virtually no flow in the stream at the time of the survey.

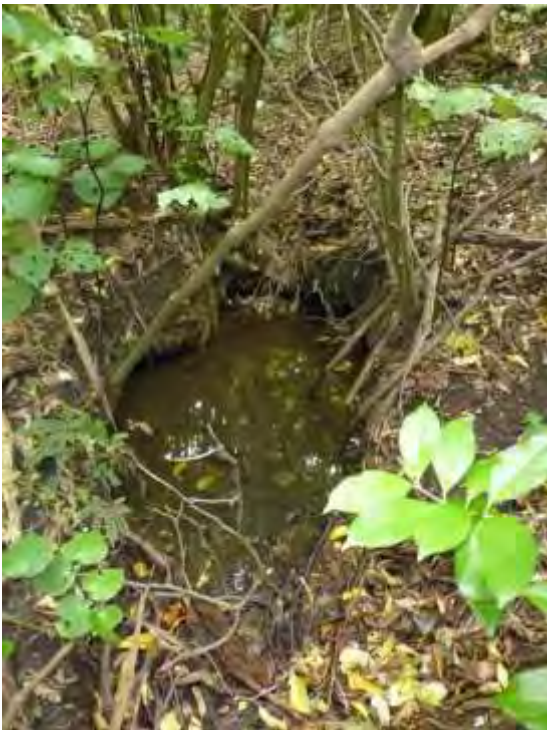
Figure 41: Example of a small pool in Bush 2 Stream

At the bottom end of the catchment near the beach there were a series of shallow, muddy pools that were isolated from each other by stretches of dry channel (see Figure 41). Habitat within these

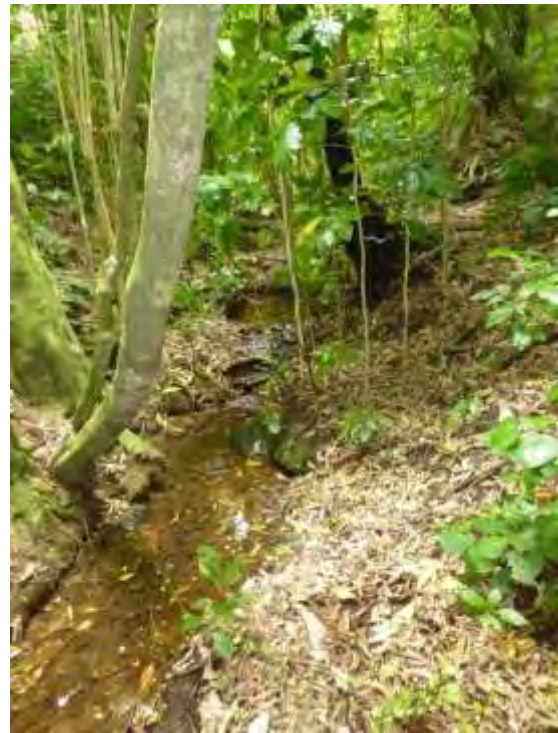
Further upstream there were a number of larger pools that did not feature the same level of bacterial growth, although there was still a lack of stream flow and the pools were isolated from one another by dry areas (Figure 45). The upper extent of water within the catchment was a shallow, muddy pool located in an area with a number of nesting boxes fixed to trees beside the stream. Upstream of this area the channel was dry, with no pools present.

Figure 45: Shallow pools in the upper part of the Bush 3 catchment

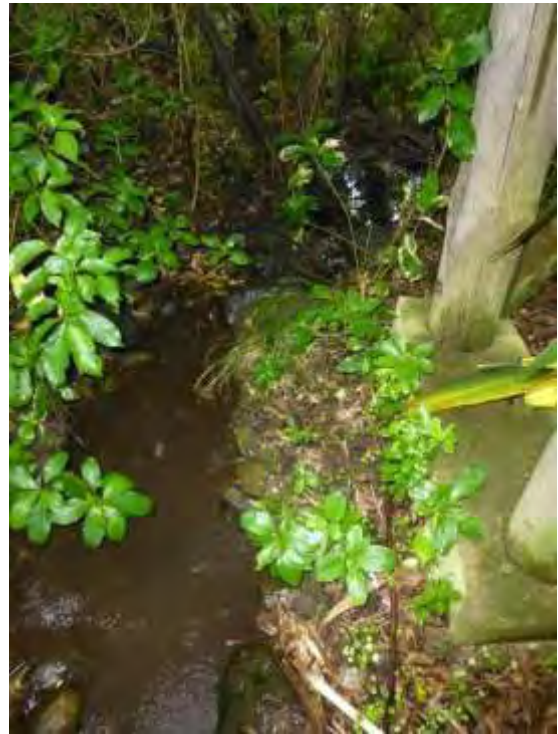
Figure 48: Small pool beneath bridge

Towards the bottom of the catchment there is a bridge where the North East Bay Track crosses the stream. At this point there was a small pool measuring 2.2m long by 0.7 m wide and 9 cm deep (Figure 48). The habitat within the pool appeared suitable for fish and it had good riparian cover, with shading of around 80%. There was a small amount of flow at the time of the survey as it was raining lightly.

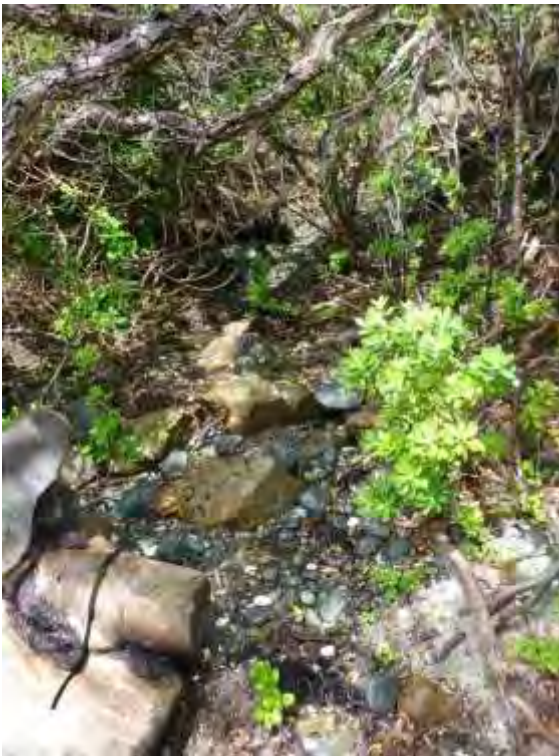
At the very bottom of the catchment there was a shallow, muddy pool above a series of small rock steps, over which there was a small flow of water (Figure 49). Immediately below this the stream terminated on the beach, where the flow disappeared beneath the shingle before reaching the sea (Figure 50). Connectivity between the sea and upper areas of the catchment would only be likely during periods of heavy, sustained rainfall where a continuous flow was maintained.

Figure 49: Small rock cascade at bottom of Silvester Wetland Stream

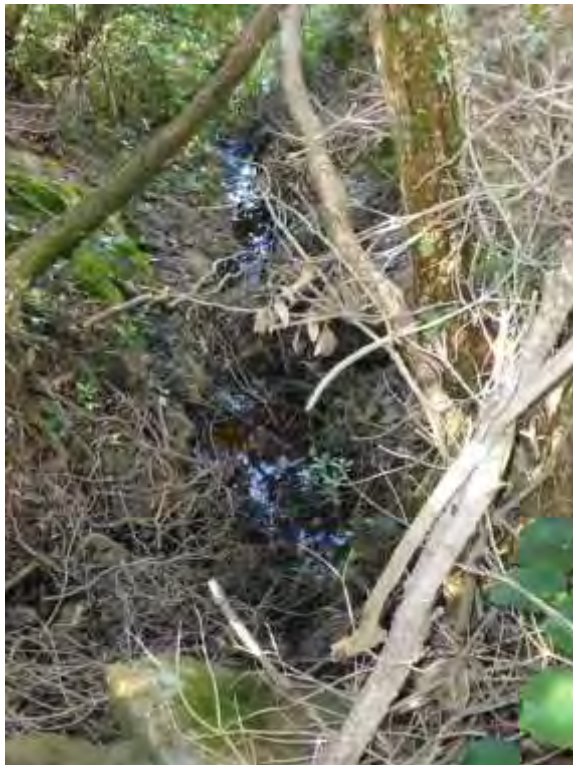
Below the second pool the stream channel was again dry for a distance of 30 metres before continuing as a series of small interconnected pools (Figure 52). The dry sections showed a distinct channel, indicating that there is a high volume of flow when a large amount of rainfall occurs within the catchment.

Figure 52: A series of interconnected pools in the Emergency Landing Stream

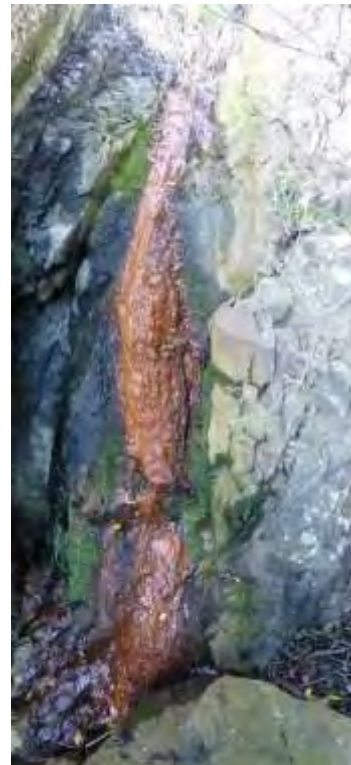
At the bottom of the catchment a small amount of flow was trickling down a near-vertical 5 metre-high rock face to form a stagnant pool at the top of the beach (Figure 53). At the time of the survey the stream flow disappeared into the rocks on the beach approximately 50 metres from the sea.

While the rock face would be scalable by climbing fish species, such as eels and banded kokopu, the amount of habitat within the stream above was very restricted.

Figure 53: Damp flow down the rock face at the bottom of the catchment

Aside from the general lack of flow in the streams there are also significant obstacles, both natural (such as the rock face at the base of the Emergency Landing Stream, shown in Figure 53) and man-made (e.g. the spillway structure on the Upper Emergency Landing Dam in Figure 9) that fish are required to negotiate in order to access permanent habitat. Improvement of fish passage over the man-made structures may assist in increasing fish populations in certain dams. This will be addressed in greater detail in Section 7.

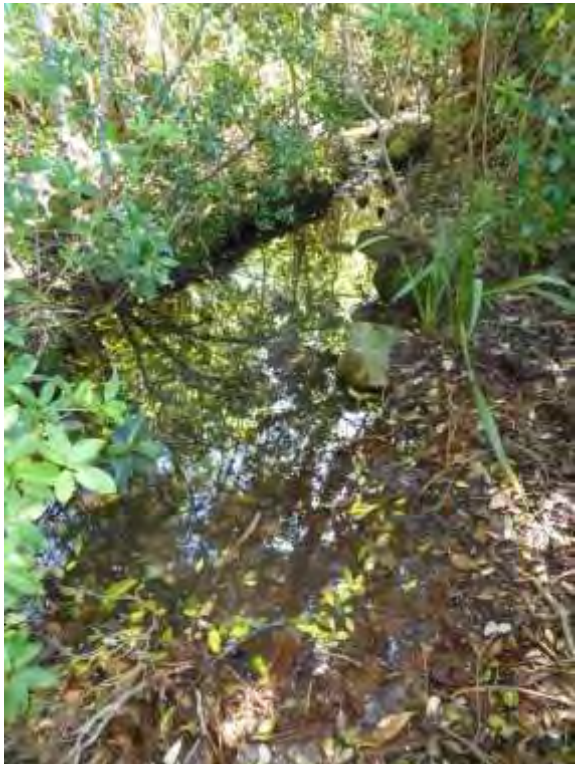
The largest pool measured 2.5m in length by 1.2m wide and 0.7m deep and contained a thin layer of naturally-occurring red-orange iron bacteria. A number of smaller pools were also present, although they were separated by sections of dry channel.

Figure 55: Large pool in Lighthouse Valley Stream
